Property name:	Kaarstadbygningen	Total Concept method Step 1. Creating the action package
Property owner:	Statsbygg	
Consultants:	SINTEF Byggforsk

Building and its use

Year built: 1922
Area: 2 800 m² Heated area
Type of building: Universitet/Høgskolebygning

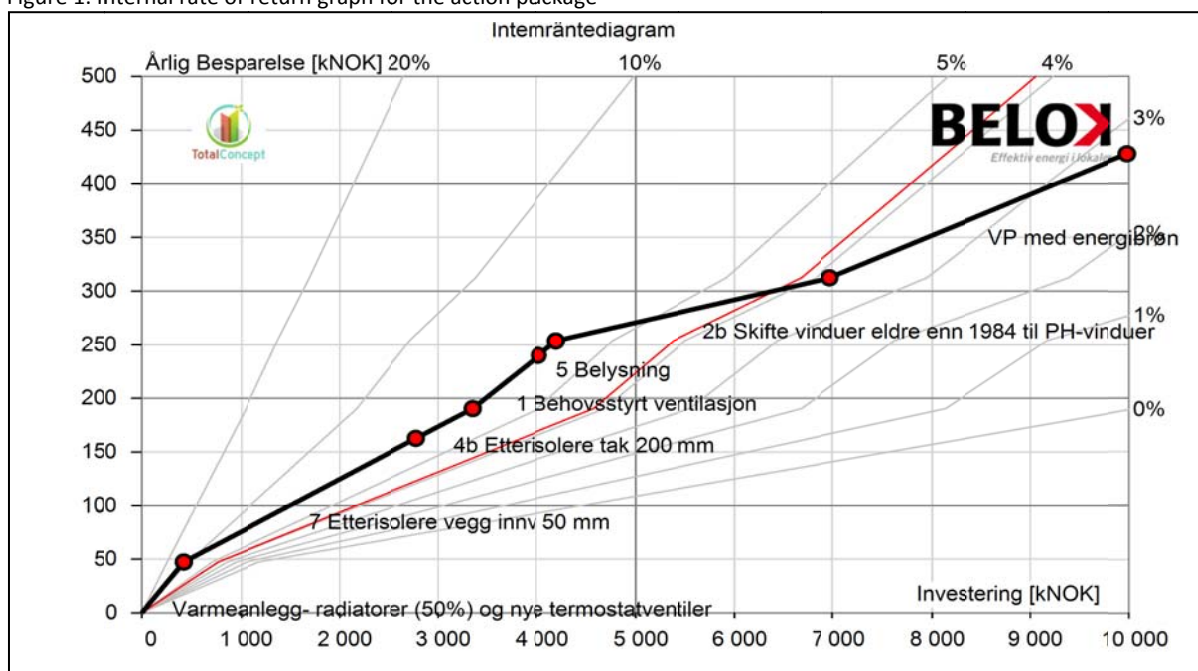
Figure 1. Internal rate of return graph for the action package

The action package reduces the delivered energy by 277 200 kWh/year, 100 kWh/m²year.
The action package investment cost is 4.2 million NOK and provides a summed IRR of 5.95%.

With the help of the Total Concept method an action package with 5 energy efficiency measures defined as profitable.

- 1 Heating system- replace radiators (50%) and new thermostatic valves
- 2 Added insulation wall internally 50mm (requires building physical assessment)
- 3 Added insulation in roof floor 200 mm (requires state of cultural heritage professional)
- 4 Demand controlled ventilation
- 5 Lighting
