Property name: Kiriku 2/4, office building
Property owner: State Real Estate Ltd.
Consultants: Estonian Society of Heating and Ventilation Engineers

Total Concept method

Step 3. Follow-up

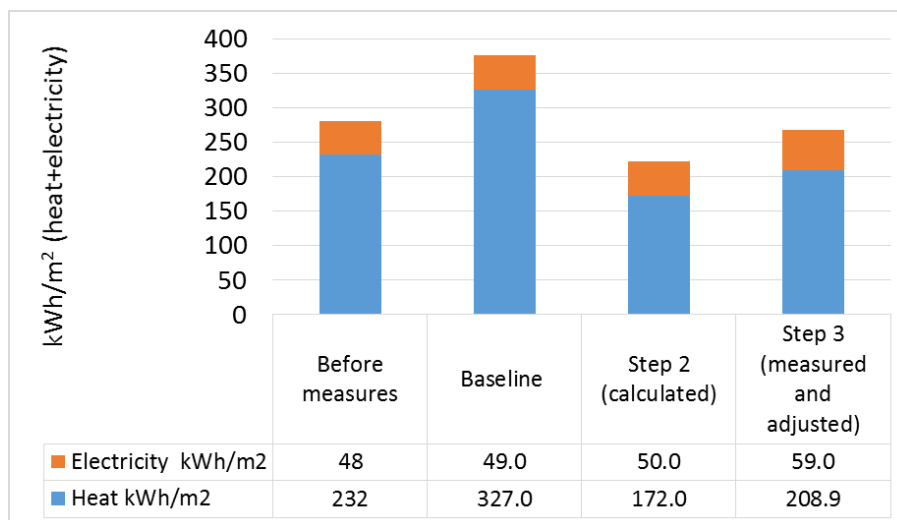
Figure 1. Outcomes after Step 3 compared to baseline.

Figure 1 shows the measurement outcomes in Step 3 compared to estimated baseline in Step 1 and calculated values in Step 2. There is no split between electricity for building operation a tenant.

According to the measurement outcomes of Step 3, the total net energy use is about 268 kWh/m². We expect net energy use to be further reduced due to operational experiences.

The action package carried out in Step 2 estimated to reduce the net energy use about 41 % compared to the energy use before renovation/baseline. The measured outcomes in Step 3 show the savings to be about 28.4 %.

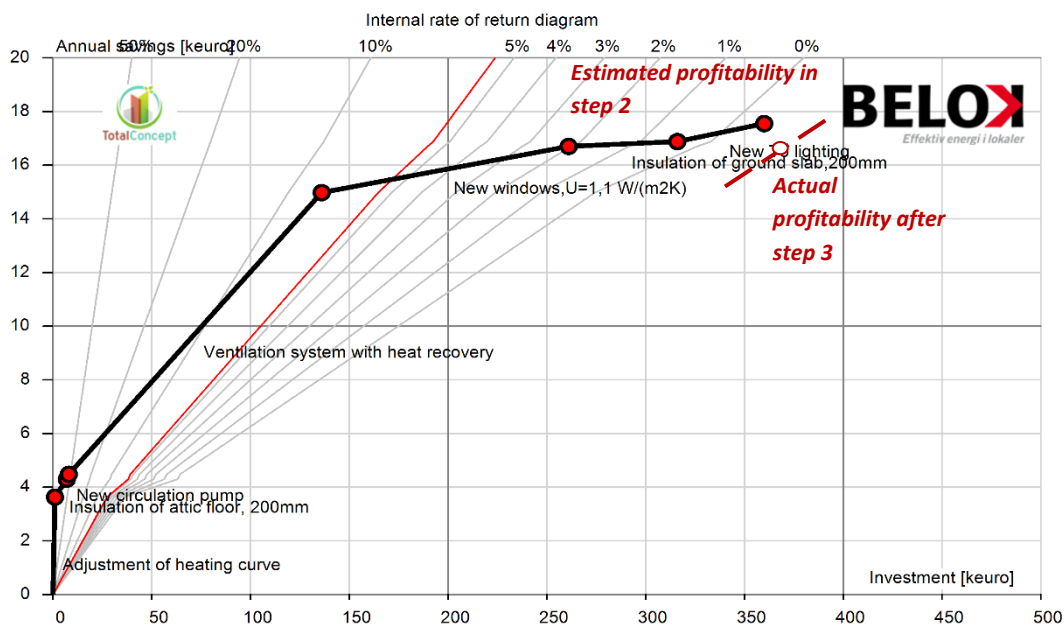
Figure 2. Outcomes of the profitability of the action package carried out at the Kiriku 2/4, office building. Relative energy price increase is 2 %.

The actual profitability outcomes are summarized in Table 2. Figure 2 shows the calculated profitability for the action package in Step 2 together with the true profitability that was calculated after Step 3. The calculated profitability for the package in Step 2 was negative as well as actual achieved profitability during Step 3.
