Property name: Norrtälje prison- Building 9
Property owner: Specialfastigheter
Consultants: CIT Energy Management AB

Total Concept method

Step 2. Carrying out the measures
 Step 3. Following up

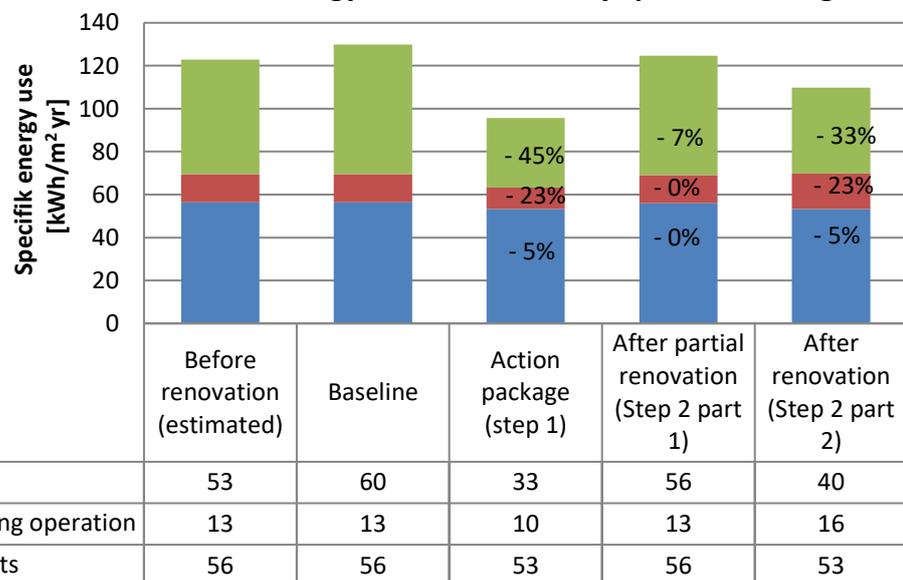
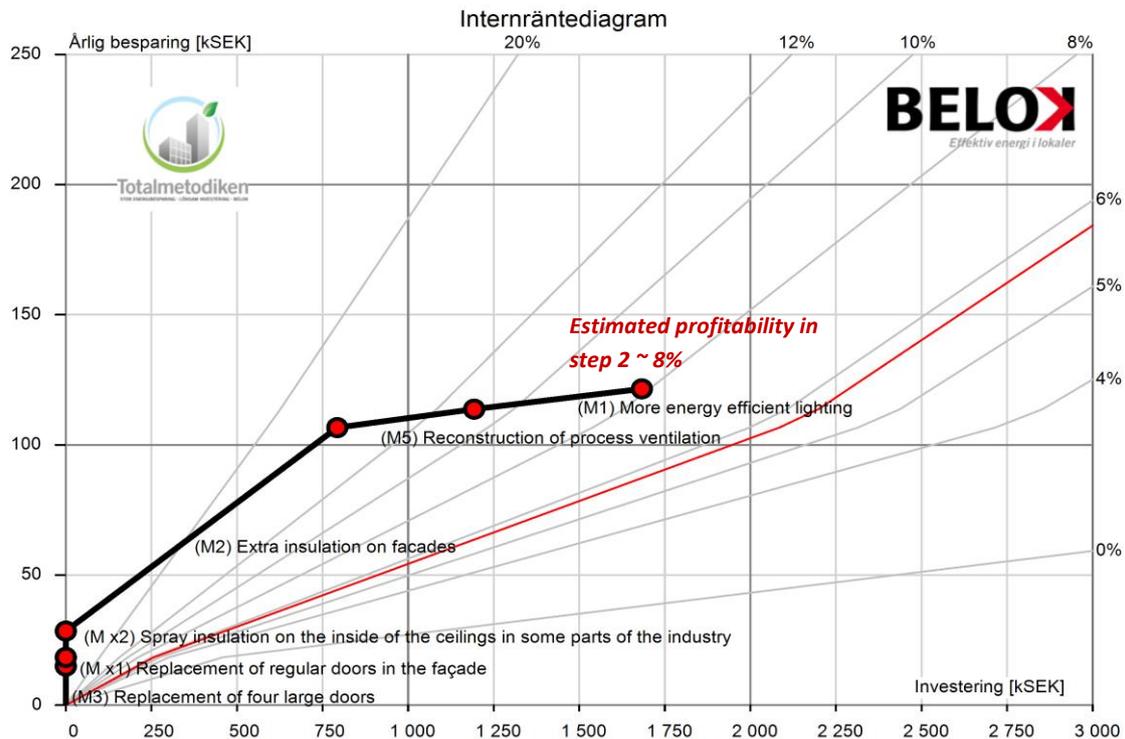
Total energy use of the Norrtälje prison Building 9

According to the estimations the action package with planned measures in Step 2 will lead to total specific energy use of the building about 110 kWh/m² per year. The total heat energy use after renovations will be about 40 kWh/m² per year and total electricity use about 69 kWh/m² per year, where majority is used by the tenants. With the action package carried in Step 2 the total building energy use is estimated to decrease about 15 % compared to the new baseline and about 10 % compared to the energy use before renovation. The energy use for building operation (BBR) will decrease about 23 % compared to the baseline and about 15 % compared to measured energy use before renovation.
