Property name: Kiriku 2 / Kiriku 4, Tallinn
Property owner: State Real Estate Ltd
Consultants: Estonian Society of Heating and Ventilation Engineers

Total Concept method

Step 1. Creating the action package

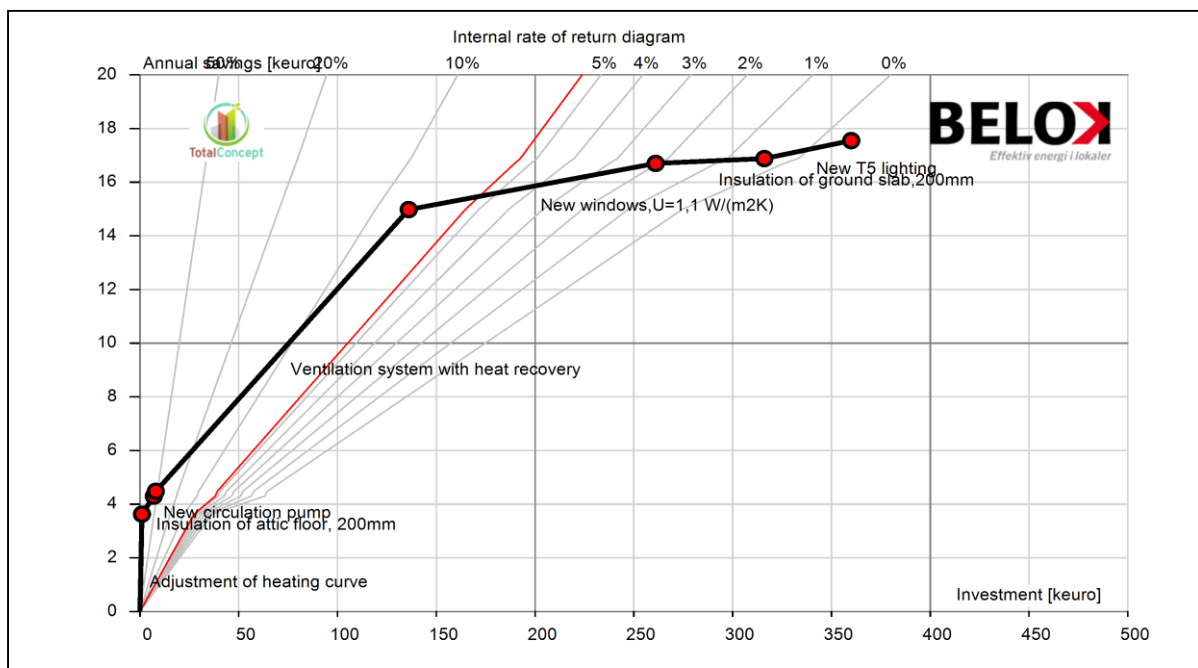
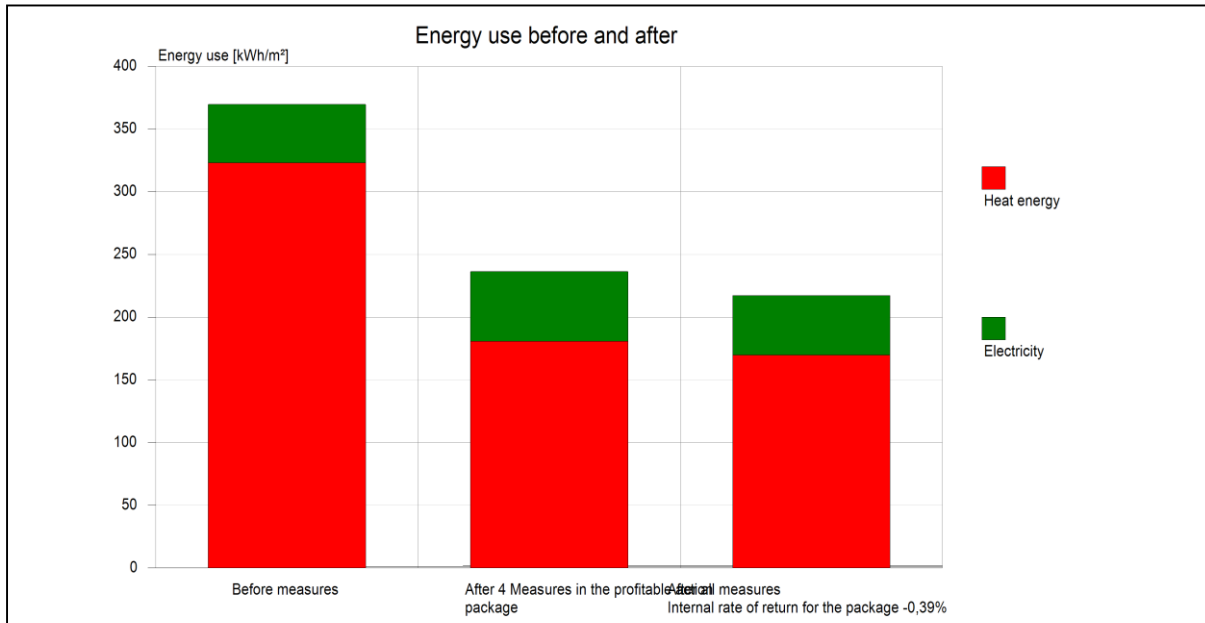
Summary of the measures in the action package

Measure	Investment cost keuro	Cost saving keuro/year	Energy saving MWh/year
1 Adjustment of heating curve	1	3	59
2 Insulation of attic floor, 200mm	6	0	11
3 New circulation pump	1	0	2
4 Ventilation system with heat recovery	128	10	178
5 New windows U=1,1 W/(m2K)	125	1	28
6 Insulation of ground slab,200mm	55	0	3
7 New T5 lighting	44	0	5
- Sum	360	17	286

The property owner's profitability demand is 5.5%. The internal rate of return of the action package is about 8 %. The total energy saving potential is approximately 36%. District heating use can be reduced by about 270 MWh/year, but electricity use will be increased by 17 MWh/year.
